NIOSH
Fire Fighter Fatality Investigation
and Prevention Program

Career Fire Fighter Dies and Three Are Injured In a Residential Garage Fire - Utah

Fatality Assessment and Control Evaluation Investigative Report #F2000-23

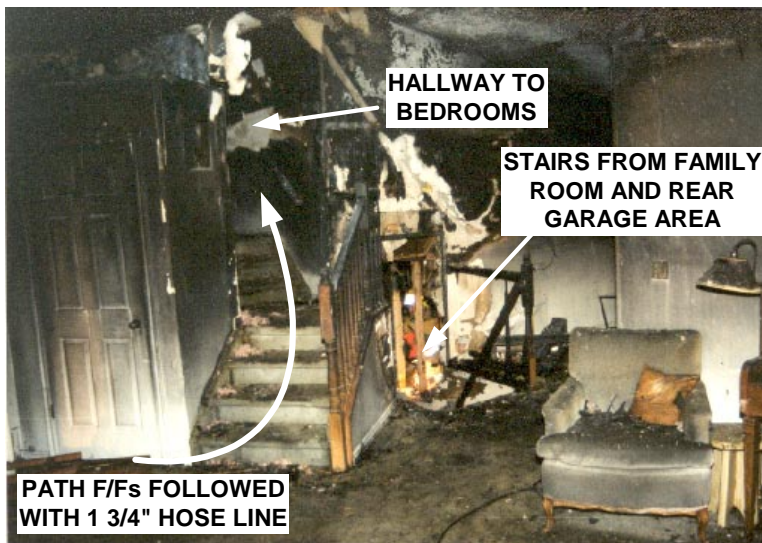
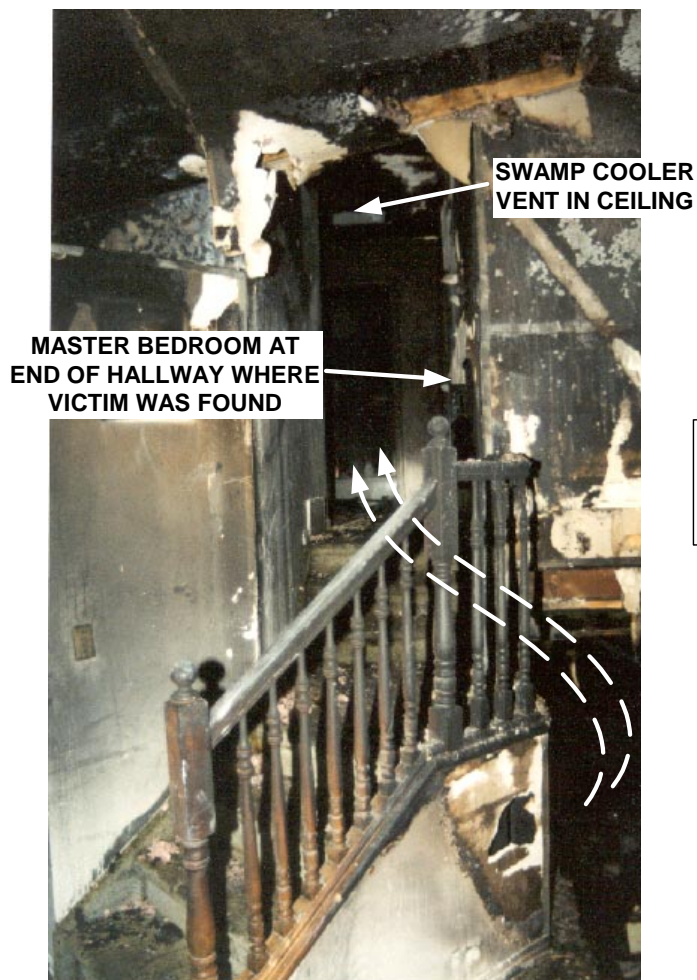
Figure. Interior Views of Stairwell

3. ***Sizing up the stairway design.*** The type of stairway leading to the floor above must also be evaluated by the fire fighter. An open stairway, such as the one found in this structure, is the most dangerous stairway a fire fighter can climb when searching above a fire. It becomes a chimney flue, allowing the flame, heat, smoke, and toxic gases generated by the fire below to flow up the open stairway leading to the second-floor bedrooms.

The findings of the State Fire Marshal's report and the fire department's fire investigation report both concur that the family room on the ground floor flashed over, with the contents of the room being totally consumed by fire (see Diagram 2). This flashover would have produced the sudden increase in temperature reported by all of the fire fighters who were inside the structure just before exiting. The open swamp cooler vent located above the fire fighters at the end of the hallway (see Diagram 1) was vertically ventilating the upper portion of the structure. The vent cover in the ceiling was not in place. The ventilation system had been recently serviced by a technician. This created a chimney effect, drawing heat from the family room, up the open stairway, and in the direction of the opening for the swamp cooler vent directly above the Lieutenant, Fire Fighter #1, and the victim (see Diagram 3). The Lieutenant who was assigned to provide assistance to Fire Fighter

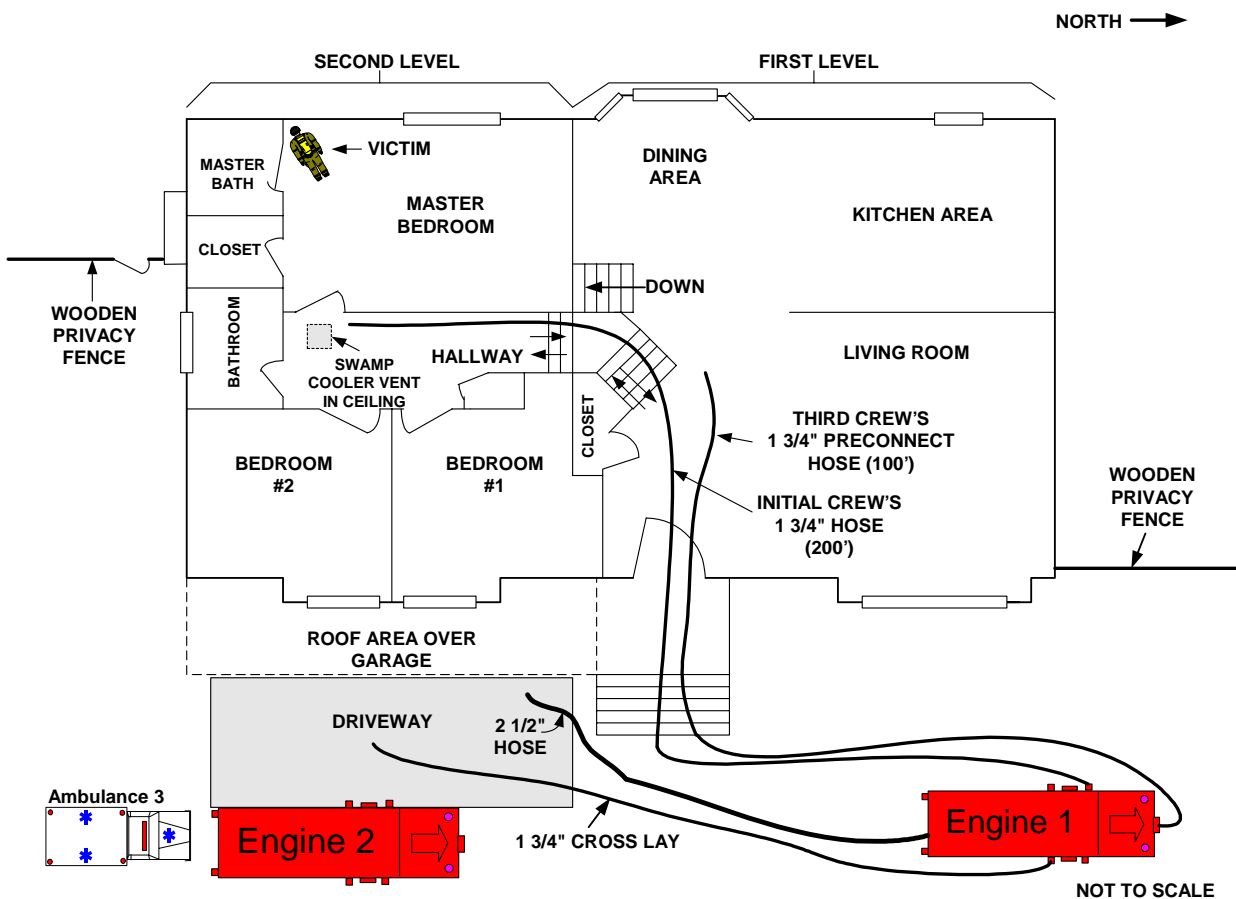
Diagram 1. Floor Plan

Diagram 1). Having zero visibility, they broke out the dining room window to help ventilate some of the smoke from the structure. The fire fighters from the second crew reported that the heat intensified after they broke out the window. At approximately the same time, the fire fighter from Engine 2 saw a glow in the back of the garage and was concerned about pushing fire onto the crews inside. He reported this to the IC and was told to hold off on attacking the garage fire. It was at approximately this same time that the victim was exiting the master bedroom and the Lieutenant turned and saw a glow at the end of the hallway near the stairway. The heat was building rapidly, so the Lieutenant took the nozzle from Fire Fighter #1 and attempted to spray water toward the end of the hallway. *Note: Unknown to the Lieutenant and the fire fighters, an open swamp cooler vent was directly above them in the ceiling (see Diagram 1, Diagram 3, Photo 2, and Figure).* The Lieutenant was on his knees and had to turn his upper body, pulling the hose line around his mid-section. The charge on the line dropped just as the Lieutenant turned to spray water toward the end of the hall. When he opened up the nozzle, the water pressure was inadequate, making it impossible to knock down the heat. *Note: The reason for the sudden decrease in the water pressure was not determined. The driver of Engine 2 reported that no problems were ever encountered with either the water supply or Engine 1.* The heat was building rapidly upstairs, so the Lieutenant, Fire Fighter #1, and the victim attempted to move toward the end of the hall away from the heat. *Note: The Lieutenant and Fire Fighter #1 reported that the heat was so intense, it became difficult to think or function.* Due to the intense heat, the Lieutenant, Fire Fighter #1, and the victim moved farther down the hall toward the door to bedroom #2. The Lieutenant attempted to radio for help but received no response. Believing he may not have keyed the
